MacBook Pro 15" Retina Display Late 2013 Teardown

Teardown of the 15" MacBook Pro Retina, October 2013.

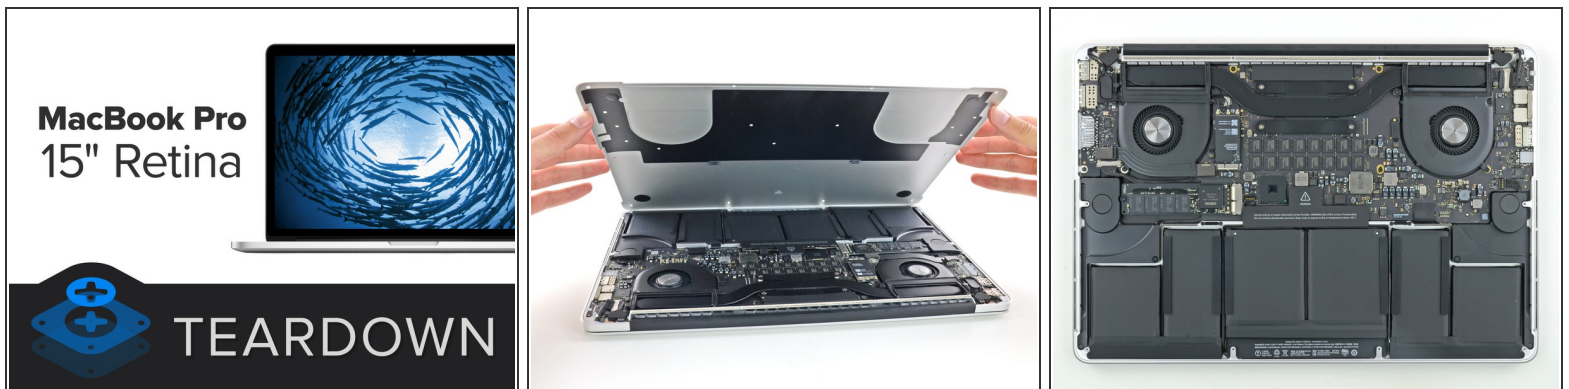
Step 1 — MacBook Pro 15" Retina Display Late 2013 Teardown

- This top-tier machine from Apple packs some impressive specs:
 - 2.0 GHz quad-core Intel Core i7
 - 8 GB of 1600 MHz DDR3L onboard memory
 - 256 GB of PCIe SSD goodness
 - Intel Iris Pro Graphics
 - 720p FaceTime HD camera
 - 802.11ac Wi-Fi wireless networking
 - Bluetooth 4.0

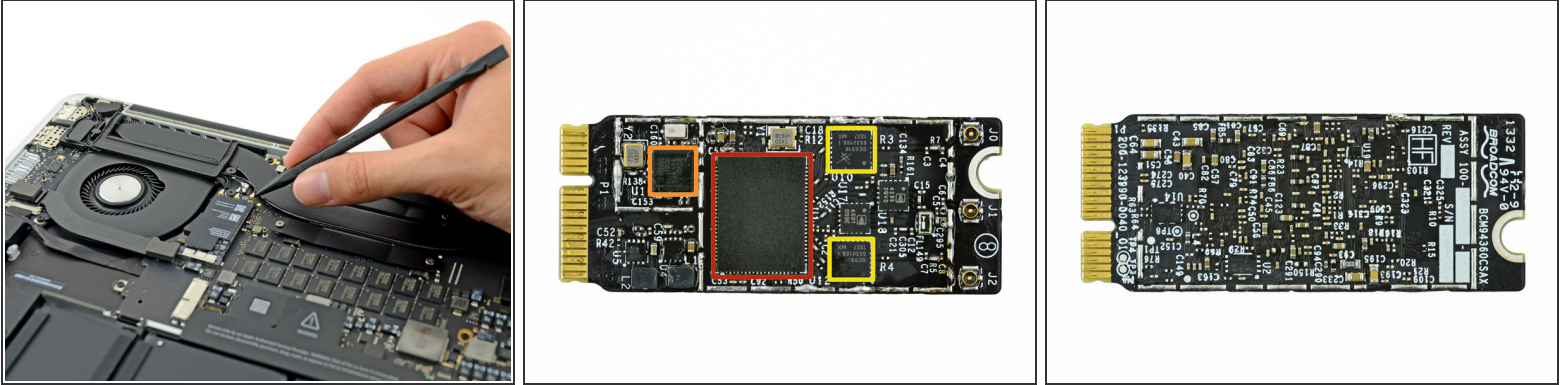
Step 2

- Easy-upgrade #2: Add a new AirPort card that supports 802.11ac Wi-Fi.
 - Apple's go-to provider of 802.11ac support is again at work. The Broadcom [BCM4360](#) on this AirPort card enables operation on the 5 GHz band at speeds up to 1.3 Gbps.
 - A Broadcom [BCM20702](#) Single-Chip Bluetooth 4.0 Processor gets Bluetoothy things done for your convenience.
 - Also in residence are a pair of Skyworks [SE5516](#) dual-band 802.11 a/b/g/n/ac WLAN front-end modules.

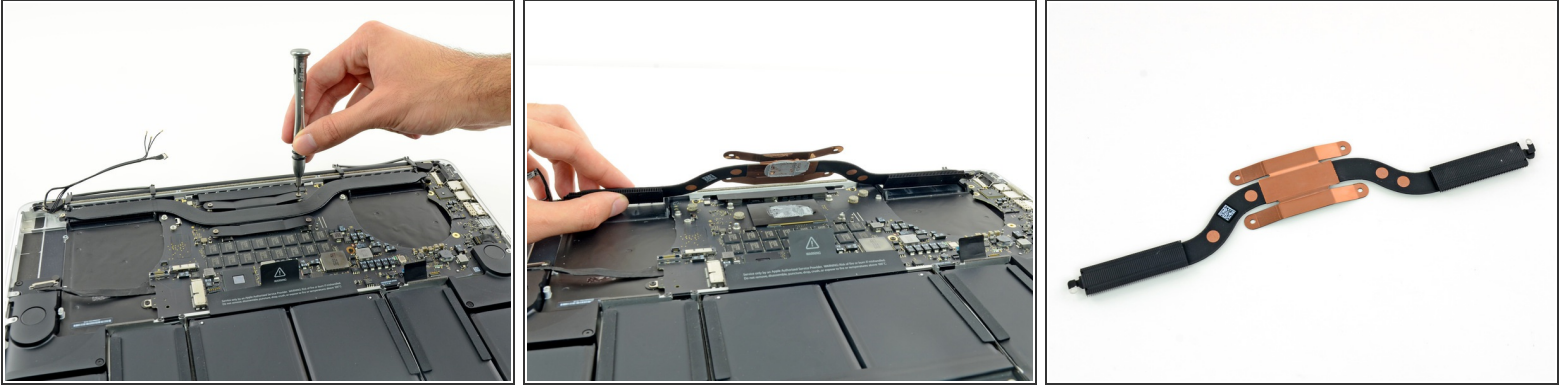
Step 3

- One of the few differences: The 15" MBP now has a sleekified heat sink with just a single thermal pad, thanks to the more closely integrated GPU—which we attribute to the "Haswellification" process, as we call it.
- ⓘ Another effect of Haswelling your MacBook: This model claims to deliver an extra hour of battery life with the same capacity cells. The more efficient processor likely contributes much to that extra hour of looking at [pictures of cats](#) on the internet.

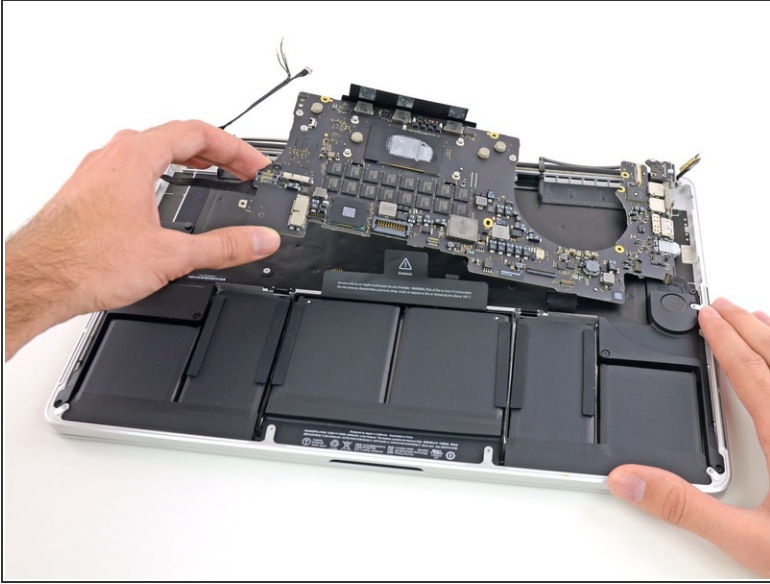
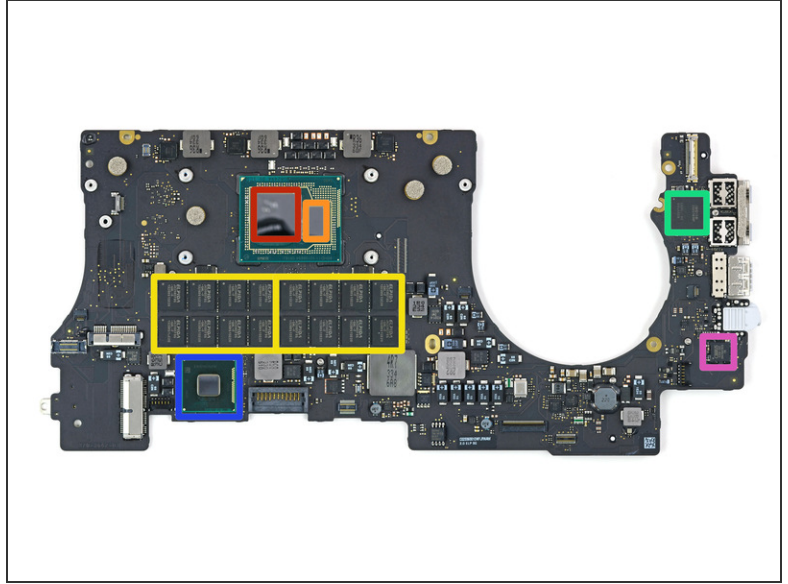
Step 4

- The most noteworthy revisions come on the logic board, including the all-new Haswell Core i7 processor, Iris Pro Graphics, and Thunderbolt 2 support:
 - 2.0 GHz quad-core Intel Core i7 processor (Turbo Boost up to 3.2 GHz) with 6 MB shared L3 cache and Iris Pro graphics
 - 128MB eDRAM cache
 - Elpida [J4208EFBG](#) 512 MB DDR3 SDRAM (16 chips for 8 GB total)
 - Intel [DSL5520](#) Thunderbolt 2 Controller
 - Intel Platform Controller Hub
 - Cirrus 4208-CRZ Audio Codec, similar to Cirrus [CS4207](#)

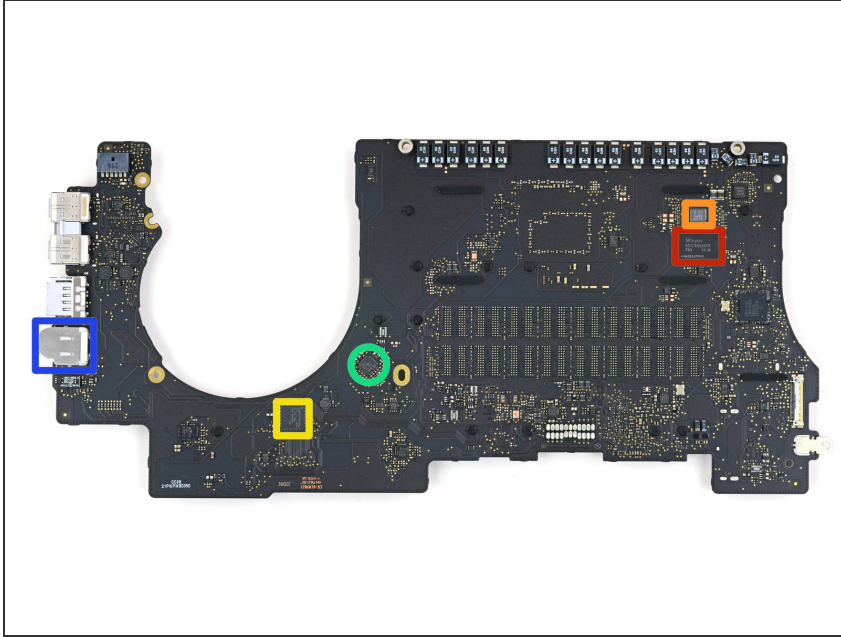
Step 5

- Back of the logic board:
 - SK Hynix [H5TC4G63AFR](#) 512 MB DDR3 SDRAM
 - Broadcom BCM15700A2
 - Cypress Semiconductor [CY8C24794-24LTXI](#) Programmable System-on-Chip
 - Texas Instruments TPS51980
 - The headphone jack is now soldered onto the logic board—break yours (easily doable through normal wear and tear) and you're looking at a thousand dollar repair

Even the headphone jack is now soldered to the logic board, which is definitely a component that can wear out over time. Users don't have to be malicious or aggressive when using the port — cyclical stress can cause it to fail either way.

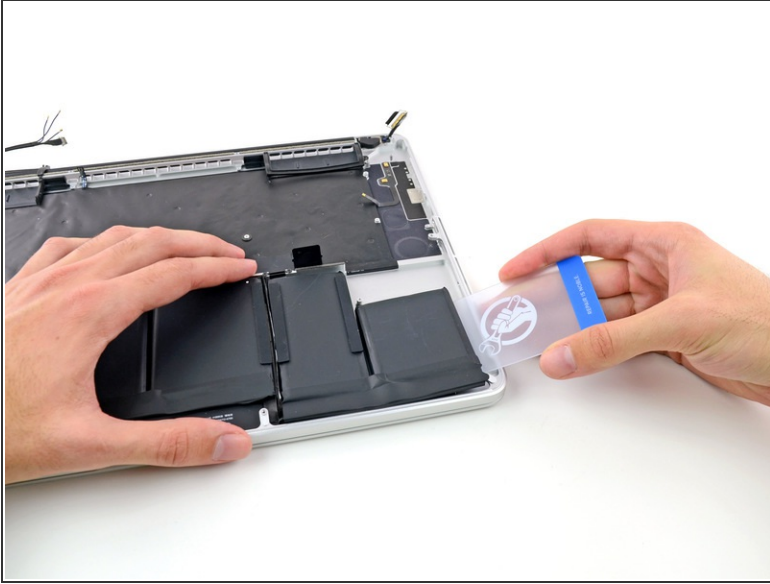
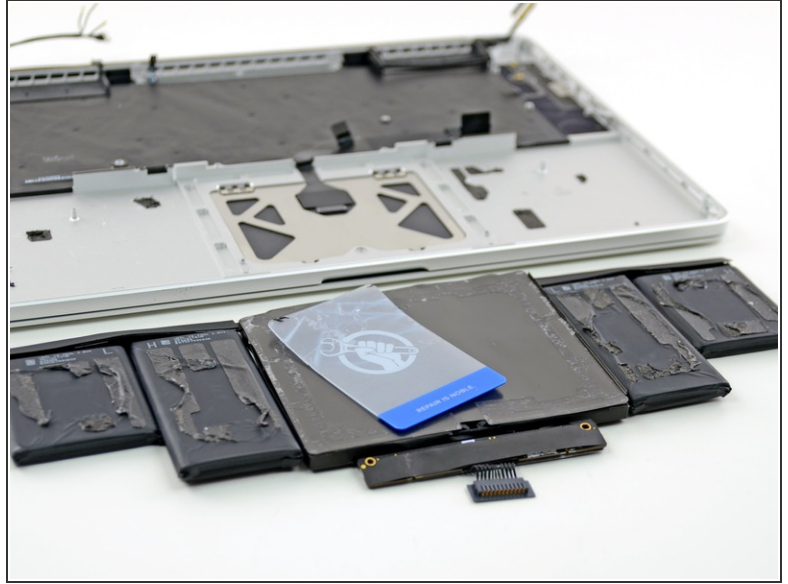
Step 6

- The moment of truth is now upon us—is the battery any easier to take out than the previous, horribly glued-in disaster?
- We're holding our breath as we gently test the waters with a plastic card...
- ...And half an hour and several skinned knuckles later, we exhale that breath in a great sigh of disappointment. The battery has the same excessive adhesive, and is just as nearly-impossible to safely remove as before.
- So much for evolution of design.

- The lithium-polymer battery is glued rather than screwed into the case, which increases the chances that it'll break during disassembly. The battery also covers the trackpad cable, which tremendously increases the chance that the user will shear the cable in the battery removal process.
